TWR-17542 Vol IV
Rev. A

FLIGHT SET 360L003 (STS-29)
SEALS FINAL REPORT
Volume IV

July 1989

***Thiokol* CORPORATION**
SPACE OPERATIONS

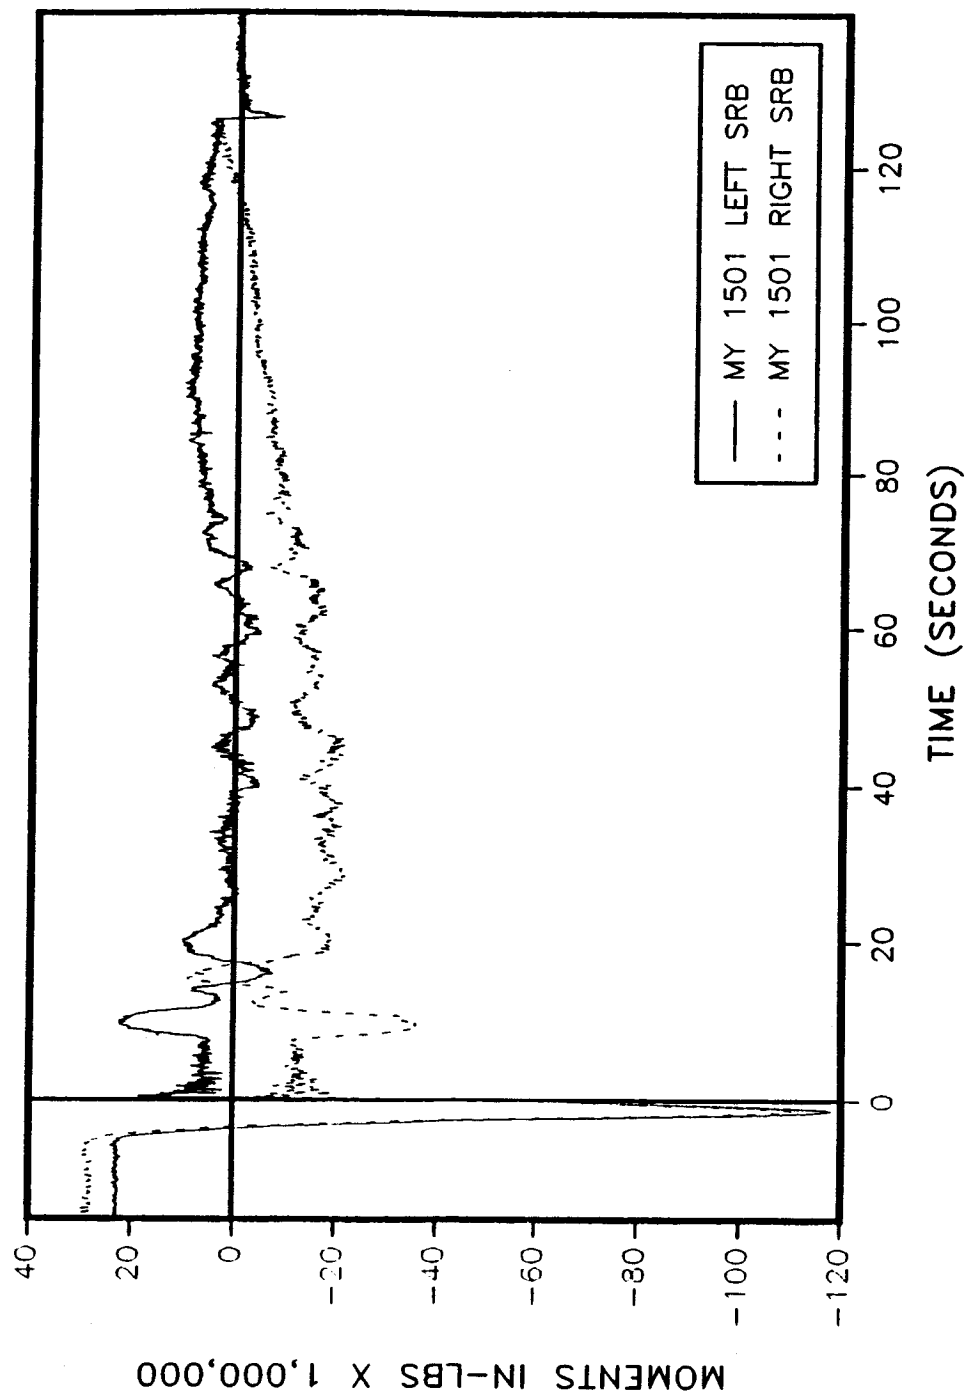
Figure 12 Bending About the Y Axis, Station 1501

Figure 12 shows a typical case of bending about the Y axis (see pages A-1 through A-23, Appendix A). Initially, the case is seen to be bending in the +Y direction which is caused by the orbiter weight. The magnitude increases more or less linearly going down the case toward the hold down point. There is an abrupt shift at Station 1501 which is caused by the struts giving added support, and the fact that the case thickness at this station is slightly greater (0.58 inch at Station 1501, 0.479 at other stations). During SSME build-up, every station experiences a change from positive to negative bending as the assembly bends over. The maximum value was -264×10^6 in.-lb at Station 1797 on the left SRB (see page A-6, Appendix A). This value compares well with the design maximum of

-304 x 10⁶ in.-lb. Upon lift-off, the values reduce significantly, coming back to nearly zero for every station. During the shuttle roll maneuver, the left SRB experiences an increase in bending, while the right SRB experiences a decrease. This is because the nozzles are vectoring to cause the roll, and the SRBs are essentially pivoting about the struts. At the end of the roll, the change for the left and right SRBs is opposite for the same reason. From this point on, the data are not very interesting, and reduces to zero. The large spike seen at approximately 124 seconds occurs at separation, and is typical of other flights.

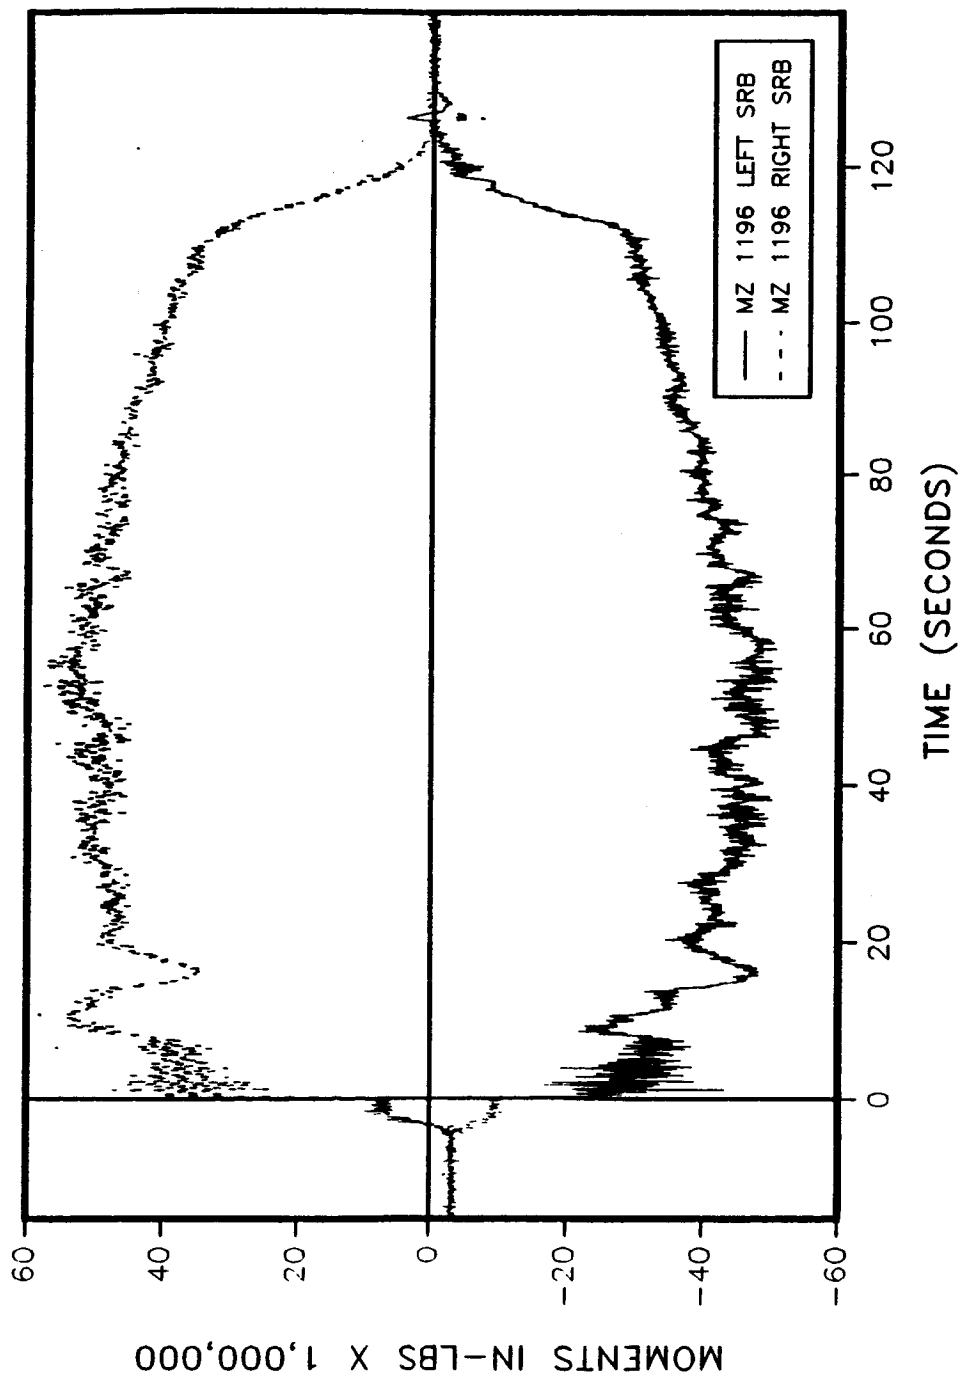
Figure 13 Bending About the Z Axis, Station 1196

Figure 13 shows a typical case of bending about the Z axis (see pages A-24 through A-46, Appendix A). Initially, the top of the motors are seen to be bending toward the external tank, which is caused by the weight of the external tank and orbiter. Moving down the motor, the bending becomes less then changes sign between Stations 1196 and 1466 as expected. At Station 1797, it changes back to the same sign as at the top of the motor, as expected. Upon liftoff, these same effects are seen with a larger magnitude because the SRBs are firing, and the motor is essentially pivoting about the attach points.

During the roll maneuver, Stations 1196 and 1466 show the same peaks as bending about the Y axis with the exception that both the left and right motors move in the same direction. This is caused by the sign convention.

During the first phase of the roll, the left motor is pushing away from the external tank, and the right motor is pushing toward the external tank. The opposite is true of the second part of the roll maneuver. Station 1797 is different from the other stations because after liftoff, it follows a more or less linear path back to zero during the flight.

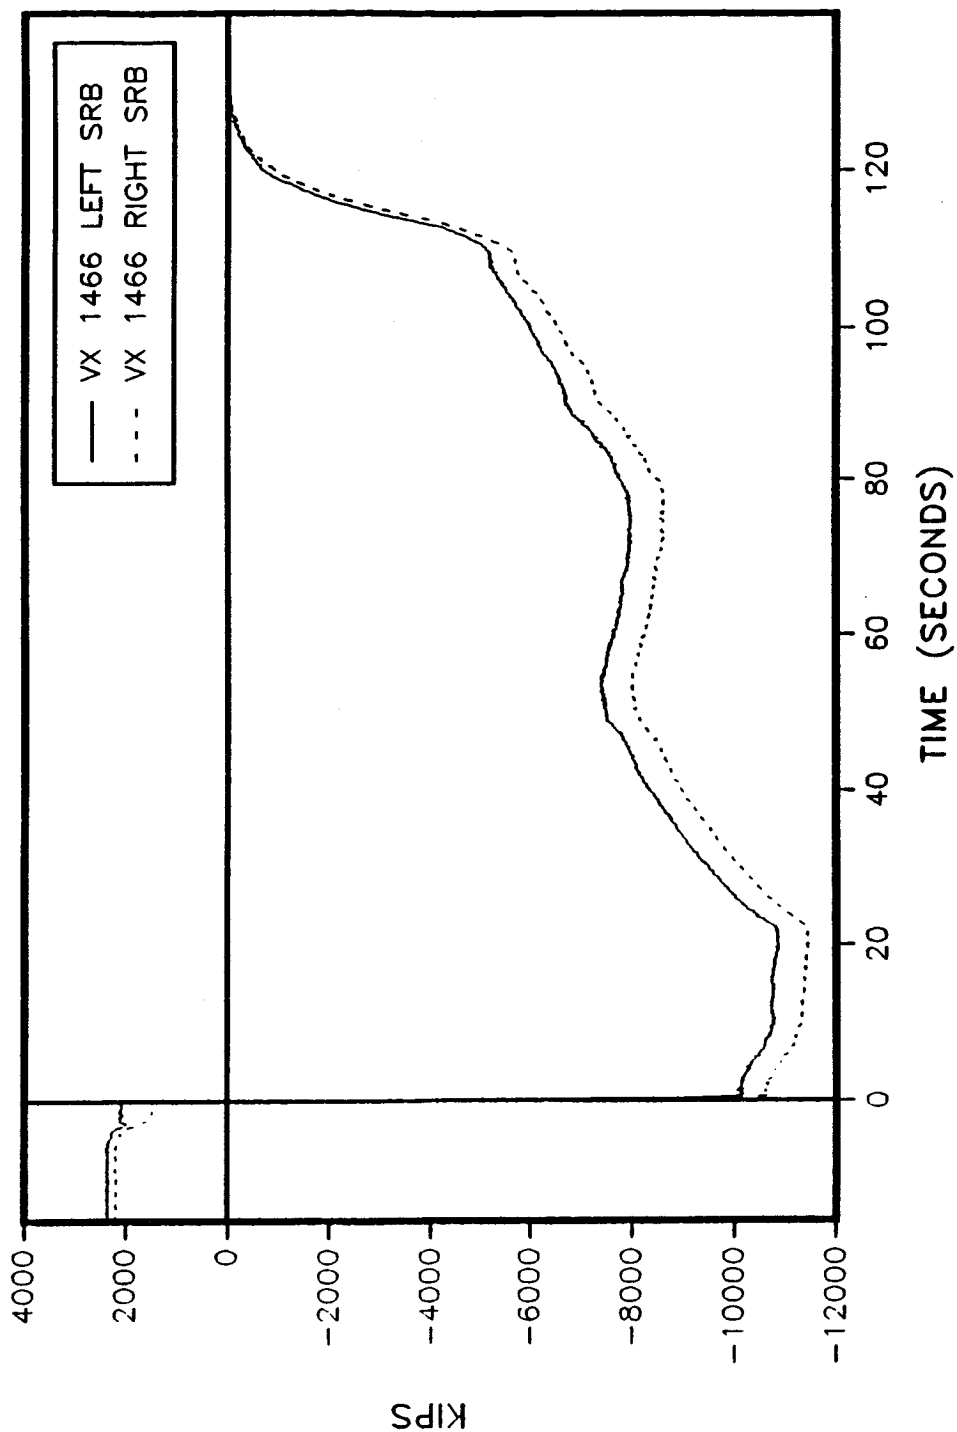
Figure 14 Axial Force, Station 1466

Figure 14 shows a typical plot of axial force (see pages A-47 through A-69, Appendix A). In this figure, a positive value represents a compressive force, and a negative value represents a tensile force. Initially the SRBs are subjected to the weight of the external tank, orbiter, and the weight of the segments above the particular station. Since these are the only forces acting axially, the result should increase linearly proceeding down the case. Station 1501 shows a marked decrease in measured strain as seen with bending about the Y and Z axis, and is caused by the increased case thickness in this region. Upon SRB ignition, the cases immediately go into tension as the motors pressurize and liftoff. The maximum value was 13,408 kips and occurred at Station 556.5 of the right motor. After this point, the shape of the plot looks like the motor pressure plots. There is good agreement between left and right motors. Some of the difference can be attributed to the fact that the gages were zeroed at the end of the flight, and the actual strain values experienced by the left and right motors, and each station, were probably not exactly zero.

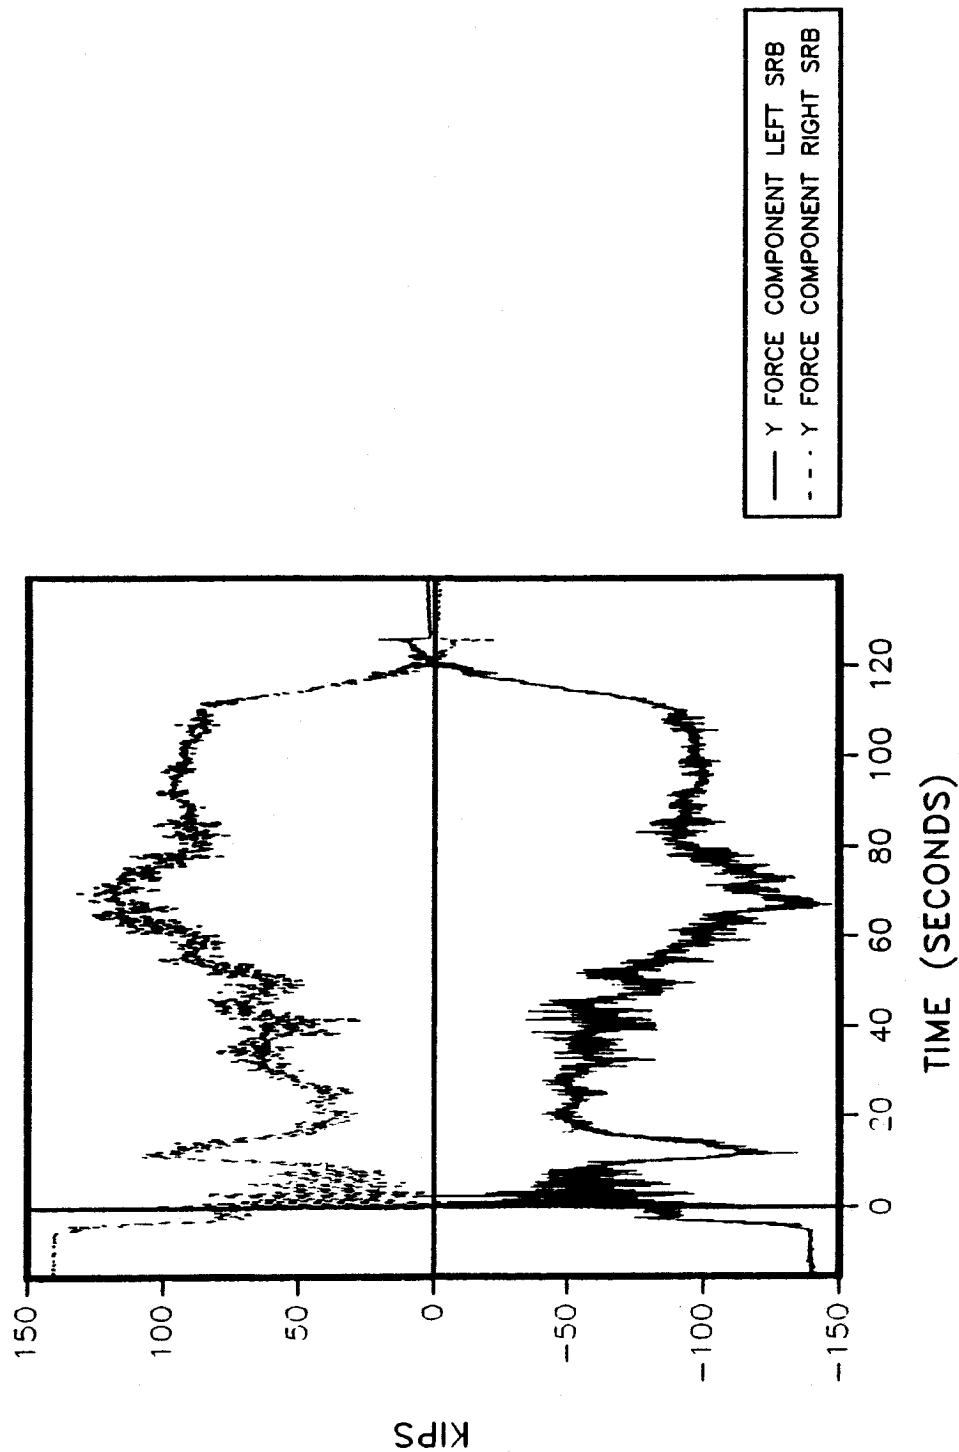
Figure 15 Strut Forces, Y Axis

Figures 15 and 16 show the resultant strut force in the Y and Z directions respectively. The left and right motors are mirror images of each other in the resultant Y force direction. The left SRB shows a positive value while the right SRB shows a negative value.

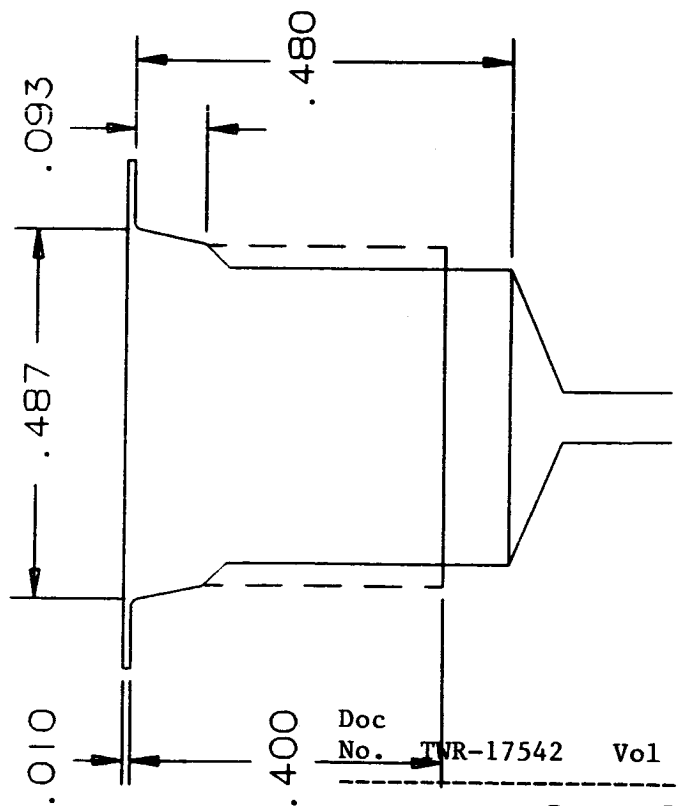
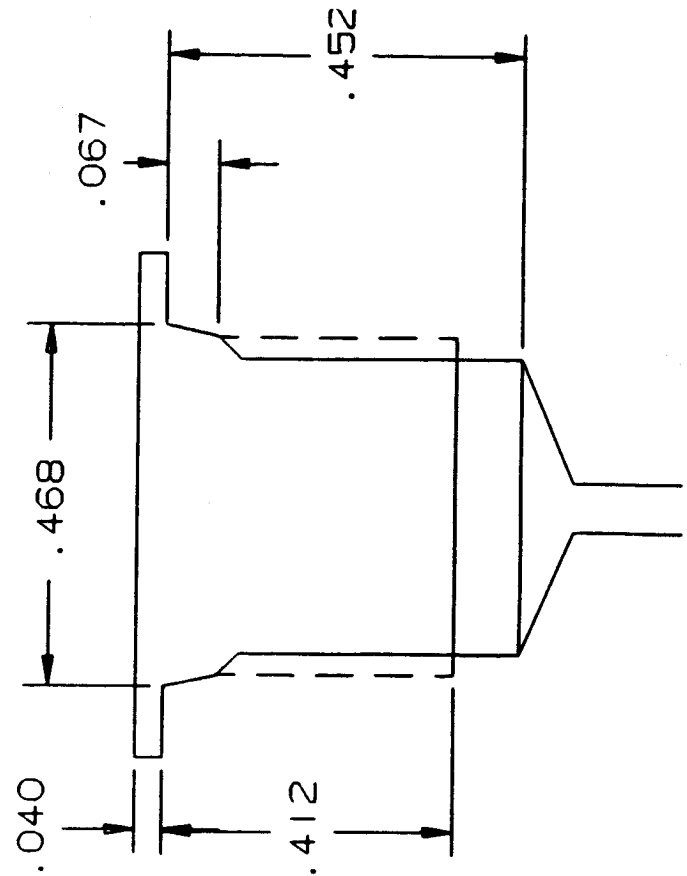
DR 174472

SECONDARY O-RING FROM RIGHT MOTOR, AFT FIELD JOINT, CUSTOM VENT PORT PLUG (1U76386-32) HAD EXTRUSION DAMAGE ON THE O.D. OF THE O-RING.

EXTRUSION DAMAGE IS FROM AN O-RING OVERFILL CONDITION IN THE SHOULDER SEAL GLAND DUE TO A DIMENSIONALLY DISCREPANT PORT. REFERENCE DRs 163057, AND 174472.

PORT CONFIGURATION (Min)

EXISTING CONDITIONS

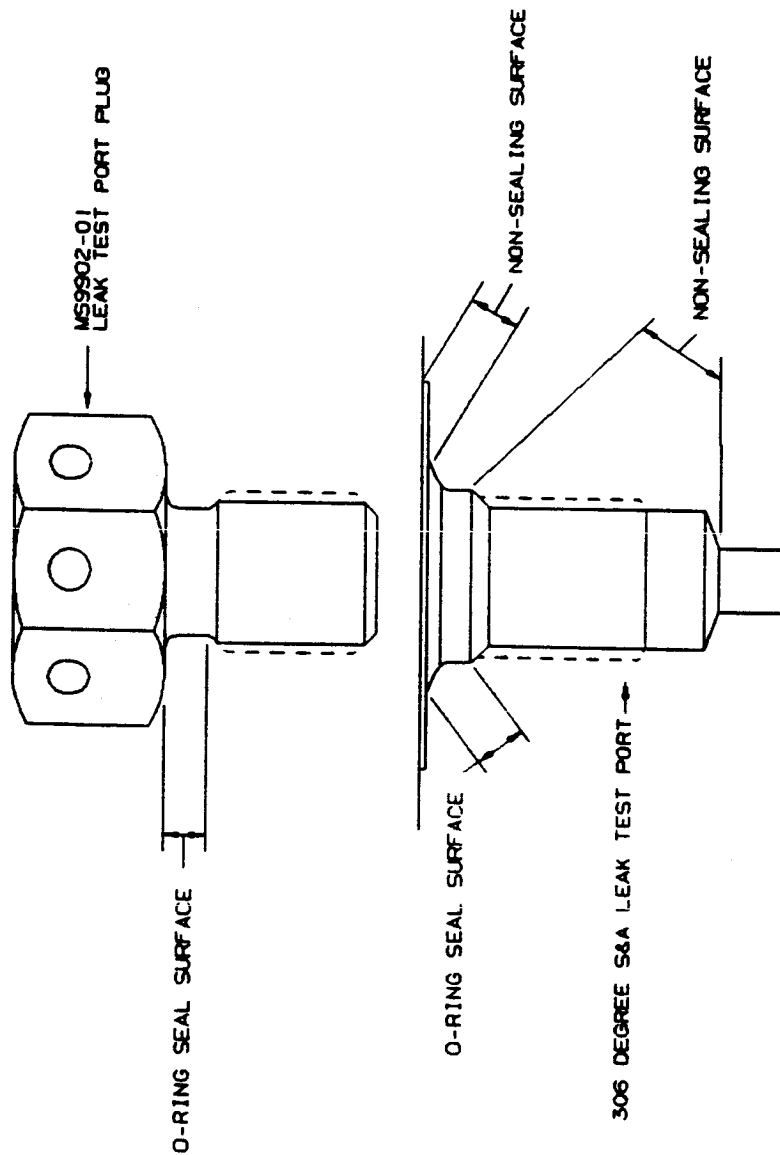
FIGURE 19- - LEAK TEST PLUG/PORT SEALING SURFACES
(FOR REFERENCE ONLY)

Five of the nine Safe and Arm devices inspected had scratches across the sealing surface of the leak check plug (2B, 3A, 3B, TEM-1, and TEM-2).

- Scratches have been found on both plugs.
- The first scratches were found on Flight 3.
- Reinspection of other plugs showed the same type (less severe) scratches.

- Worst case 3rd flight plug tests showed no leakage.
 - Plugs were hand tightened.
- Planning was inadequate at MTI and KSC.
 - Allowed the use of any type of removal tool.
 - Did not provide adequate plug inspection criteria.
 - MTI had no plug reinspection called out after removal of the original O-ring.

- Suspect plugs on Flight 5 units will be replaced.
- Suspected plugs will be returned to MTI for evaluation.
- O-rings will be replaced.
- Units still at MTI will have the suspect plugs replaced just as Flight 5.
- Planning changed at MTI and KSC to eliminate the possibility of a scratch in the plug sealing surface. (COMPLETED)
 - MTI and KSC will use a brass or non-metallic O-ring removal tool.
 - MTI and KSC will visually inspect each plug in a well illuminated area.
- Close PFAR upon completion of the above recommendations.
- All corrective actions will be completed.
